RSPB Langford Lowfields artificial sand martin bank creation

Partnership project delivered by RSPB and Lafarge Tarmac with support from Sita funding and construction by Sandinyoureye Ltd.

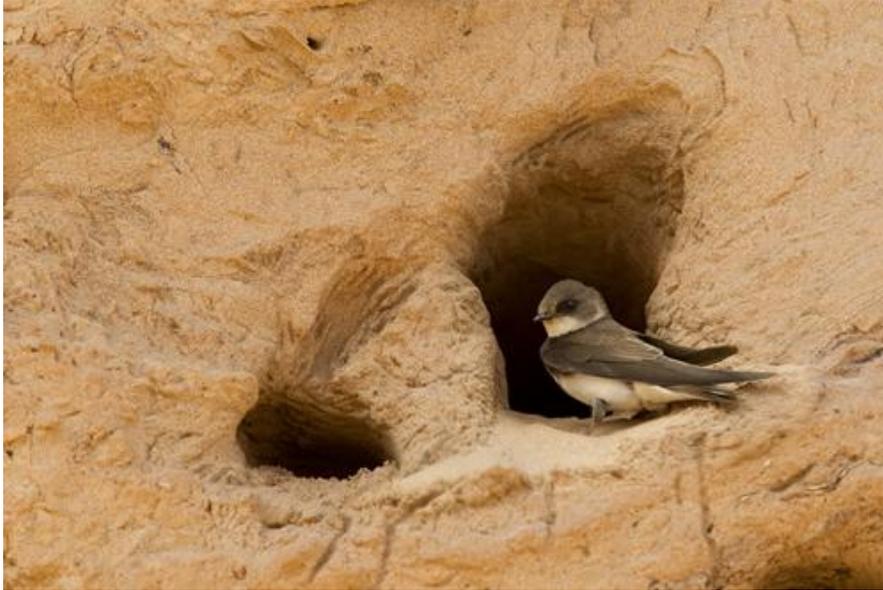
At Langford Lowfields, a 175ha reedbed restoration reserve, **Sandinyoureye** sand sculptors and RSPB designed and created an artificial sand martin bank that is purpose built to look and function as naturally as possible with sand martin nesting ecology.

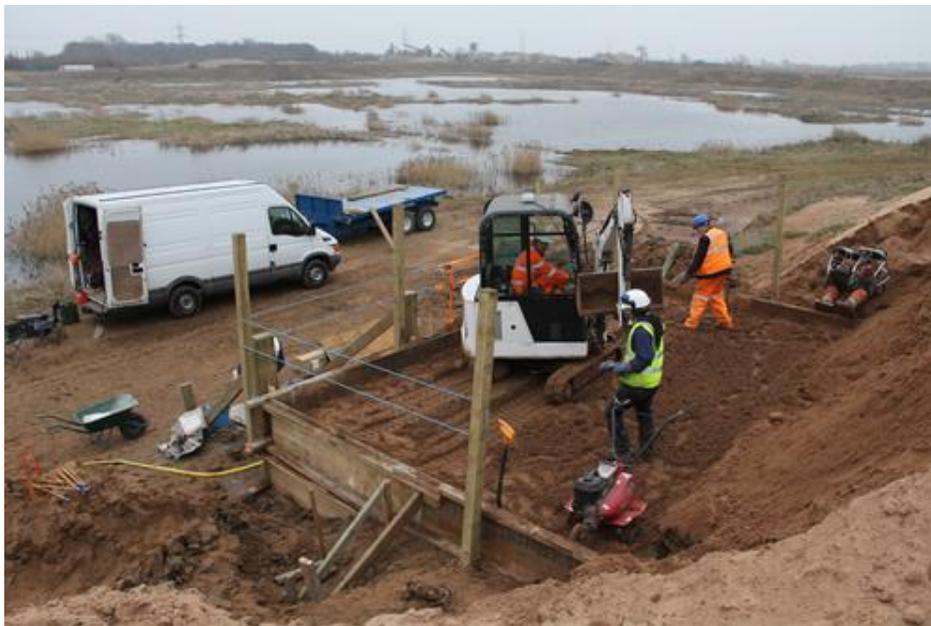
Sandinyoureye constructing the sand bank with Paul Afford plant hire on the digger.

- The main construction process involves creating a sturdy framework of wooden forms that hold the sand for compaction. The Langford structure is 7 metres wide, 2.5 metres high and 5 metres deep (to allow several years of use by carving back the face).

- Sand and cement are mixed at 100 to 1 ratio in 300mm layers which are then rotavated with large quantities of water followed by hydraulic compaction.

- This process is repeated to create highly compacted layers, raising the structural forms as required. It is critical to **ensure compaction is wet** as the quality of the final structure and settling of the sand requires large quantities of water.

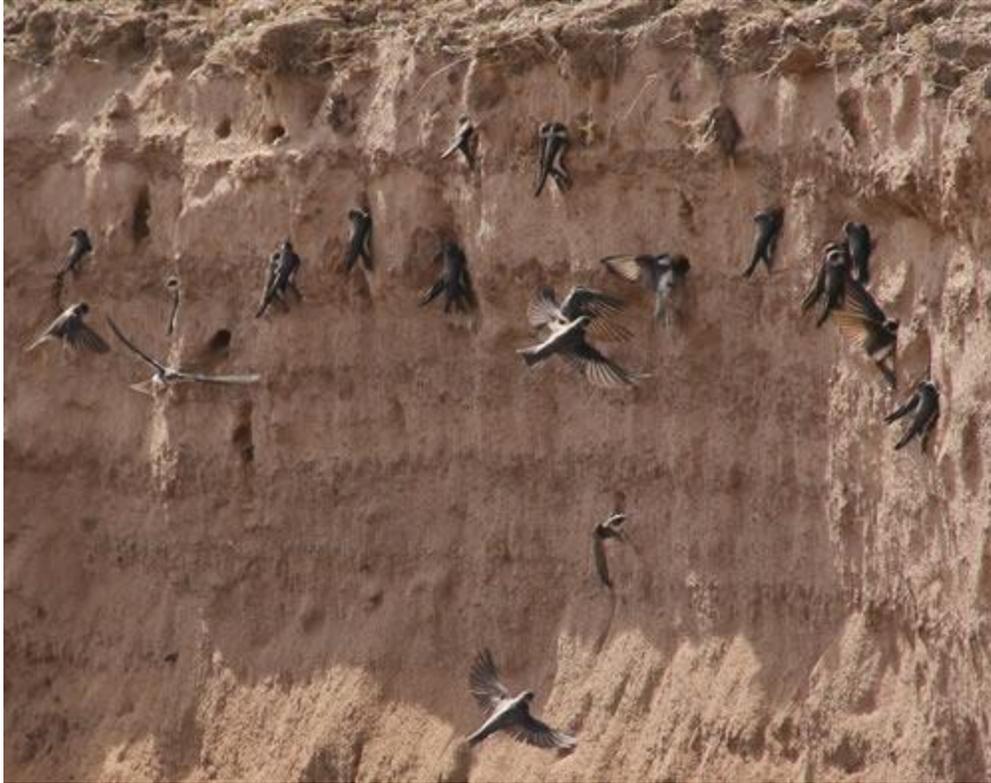
The first sand martins made nests three weeks after construction.

In 2012 the bank was occupied by 150 nests, in 2013 over 200 nests occupied. Parasite loading – in particular fleas, are a key reason for sand martin's excavating new nest chambers annually. For this reason the bank is designed so that it can be cut annually for between 4-7 years by the volunteers so a new face is exposed for each spring.

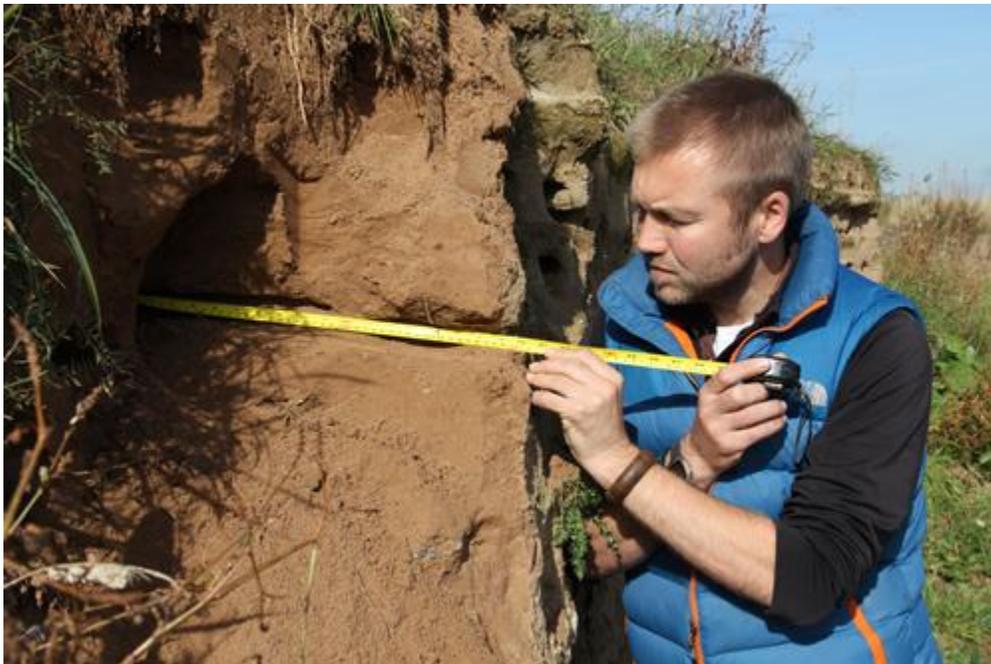
Measuring a cross section of the sand martin bank. The burrows run on a slight incline for on average of 650mm with a nesting chamber at the back

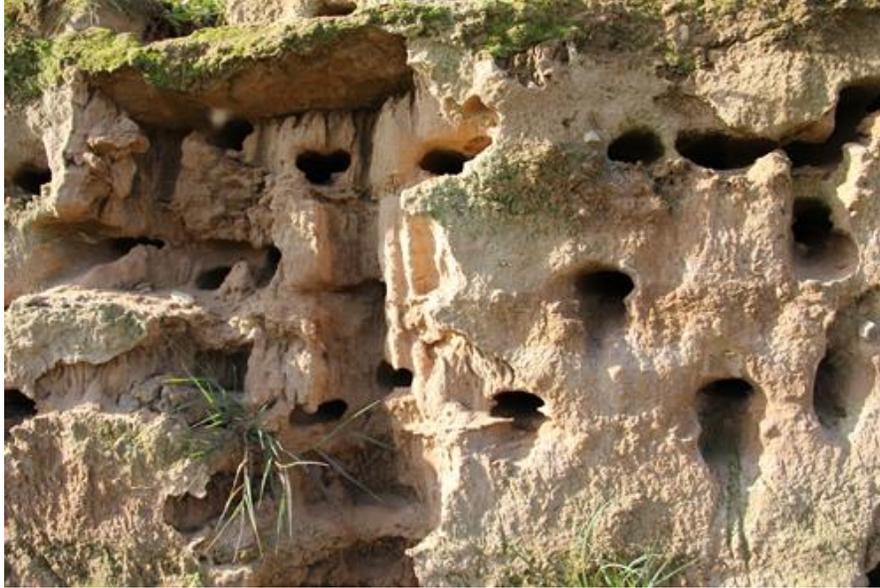
Naturalised appearance of structure

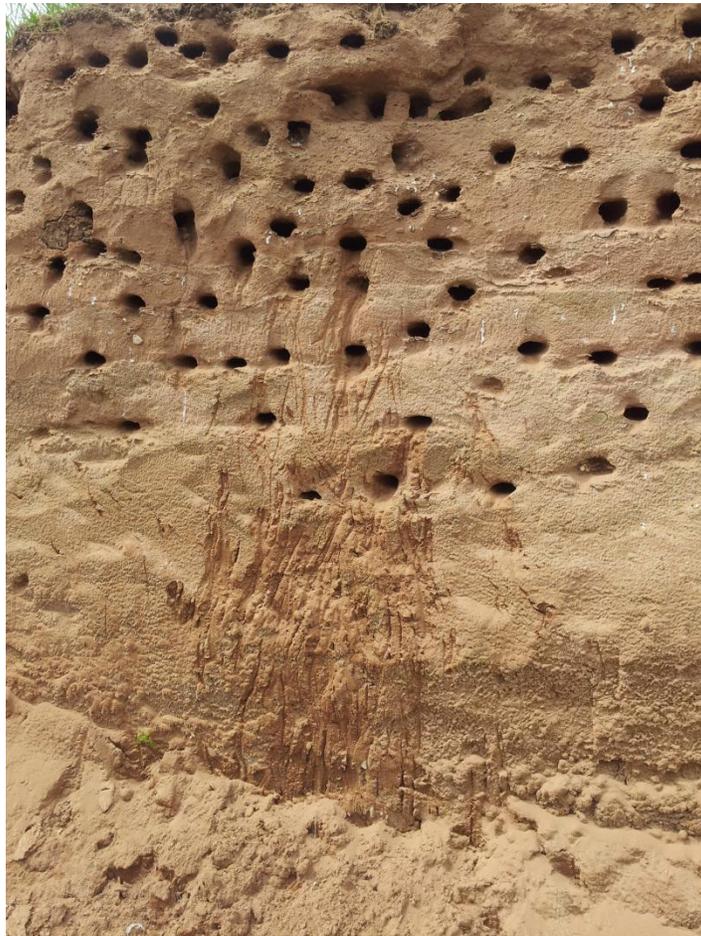
Compacted sand is critically stronger at resisting digging from fox as shown above

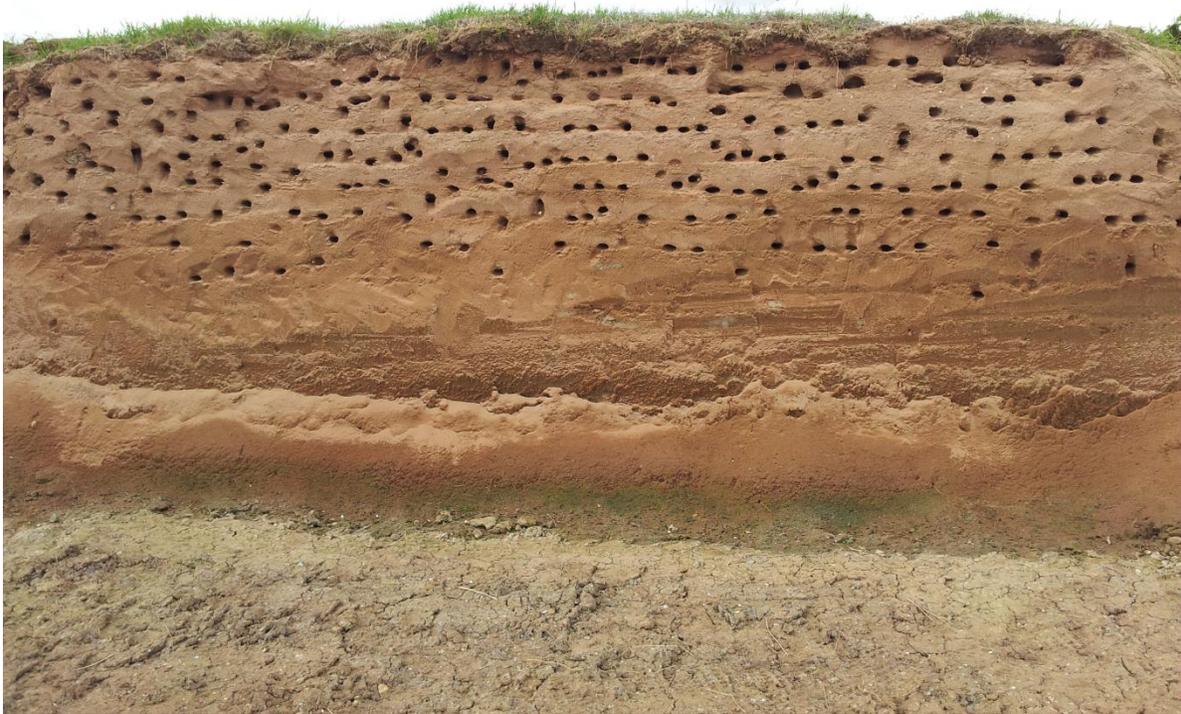
Early establishment in 2013 of the banks second year of colonists – note the face has been re-carved following winter flooding and the establishment of turf on the surface has improved.
